Section 278 Works, Long Lane / Woodmansey Mile, Beverley

Stage 3 Road Safety Audit

BELLWAY HOMES

Ref: 23-381.001.01

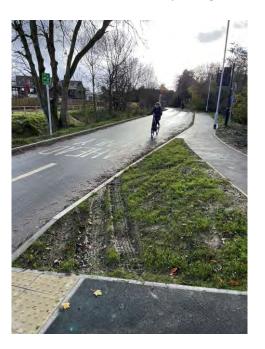
Risk of collisions between drivers undertaking banned turning movements and other junction users.

The traffic signal junction only permits ahead movements (except cycles) on all four arms of the junction. This is communicated by 'ahead only' signal heads, 'ahead only' road markings and tight junction radii. However, a significant number of drivers were observed throughout the Stage 3 RSA site visit making various banned left and right turn movements and this is likely to increase as the development is occupied by more residents. There is also evidence of vehicles making the right turn from Woodmansey Mile onto Long Lane by crossing the footway and grass verge to the south of the junction. Drivers undertaking banned turning movements (albeit at low speed) are at an increased risk of collision with other junction users who would otherwise not be expecting to encounter turning vehicles.

Turning movements to/from the development site onto Long Lane also result in a general increase in vehicle flows on Long Lane which, for the most part, is a route where pedestrians are required to walk in the carriageway. Increased vehicle flows on Long Lane therefore increases the risk of vehicle to pedestrian collisions along this road.

It is recommended that additional measures are provided in the verges to prevent drivers from driving over footway and verge in order to make banned movements.

It is also recommended that measures are implemented on street in the form of signage and carriageway markings to ensure better compliance with the Traffic Regulation Orders associated with band movements on both Long Lane and Woodmansey Mile.

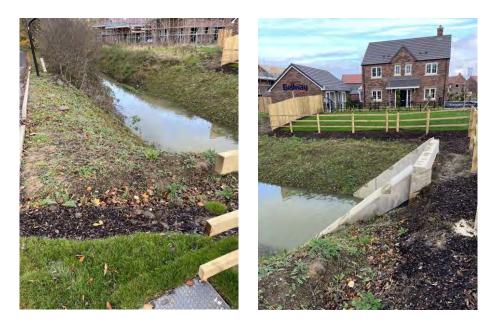
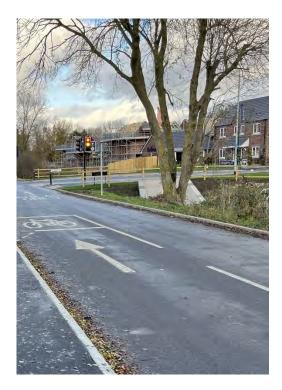
It was noted during the site visit that fencing does not extend fully along the carriageway boundary to both the north and south of the culvert across the water course which runs parallel to Long Lane. There is also a lack of fencing on the top of the headwalls to both sides of the culvert. This allows pedestrian access from the highway to the embankment and area surrounding the water course and therefore increases the risk of falls and water related injuries.

The lack of appropriate fencing at the top of the embankments allows pedestrians including vulnerable users such as children to access the area surrounding embankment directly to the east of Long Lane, to the north and south of the new culvert. The area includes steep banks surrounding the culvert which lead down to the water course and the headwalls which surround the culvert which also have no barrier in place. The absence of a barrier, the steep banks and the lack of barrier surrounding the headwalls will increase the risk of pedestrians falling down the embankment with an increased risk of injury and possible drowning.

It is recommended that fencing is extended along the boundary of Long Lane and the area surrounding the headwalls to control pedestrian access.

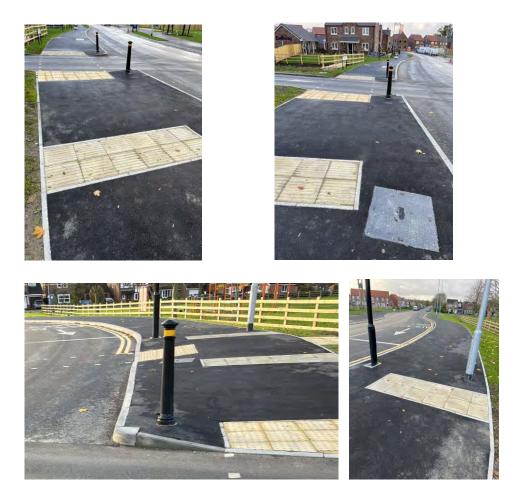
Incomplete corduroy paving and lack of suitable signage may lead to confusion and an increased risk of collisions between pedestrians and cyclists.

It was noted during the site visit that corduroy paving has only been installed across part of the footway to the northwest of the signalised junction, to the east and west of the tactile paving associated with the uncontrolled pedestrian crossing location on Woodmansey Mile. There is also corduroy paving across the footway connection to the rear of the footway, in line with the uncontrolled crossing, which provides a footpath connection heading north from the junction. There are no shared footway cycleway signs in the vicinity of the paving arrangements indicating what is shared footway cycleway and what is footway, which may result in pedestrians and cyclists being unsure as to what the status of the footway is.

The lack of signage along the northern side of Woodmansey Mile combined with the gaps between corduroy paving and the edge of the footway may lead to confusion and an increased risk of pedestrian cycle collisions in the vicinity of the uncontrolled crossing and on the northern side of Woodmansey Mile to the east and west of the signalised junction.

It is recommended that corduroy paving is extended to the edge of the footway and clear signage is provided to differentiate between shared footway cycleway and footway. Signage should also be provided to define the use of the northern footway to the east of the signalised junction on Woodmansey Mile. It is recommended that guidance contained within LTN 1/20 is considered as part of any further changes to the tactile paving and signage design.
